**NASA**  
**RL10 IGNITION LIMITS TEST  
FOR SHUTTLE CENTAUR**

**FINAL REPORT**

**CONTRACT NAS3-22902**

**Prepared by  
United Technologies Corporation  
Pratt & Whitney  
Government Products Division  
P.O. Box 109600, West Palm Beach, Florida 33410-9600**

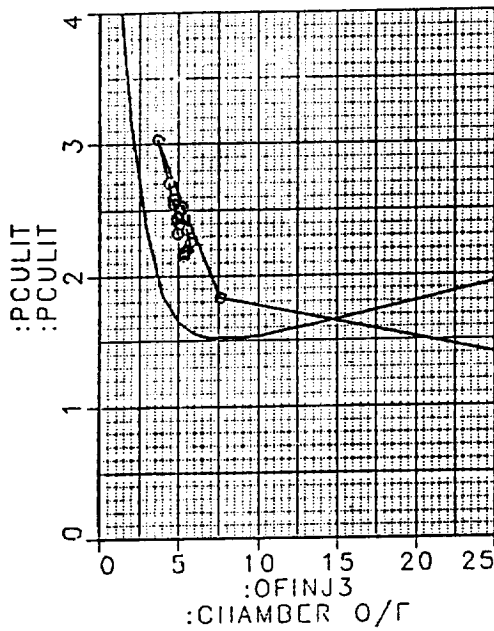
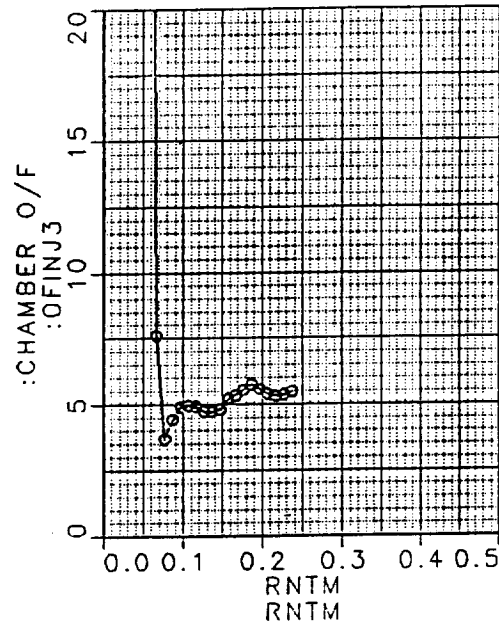
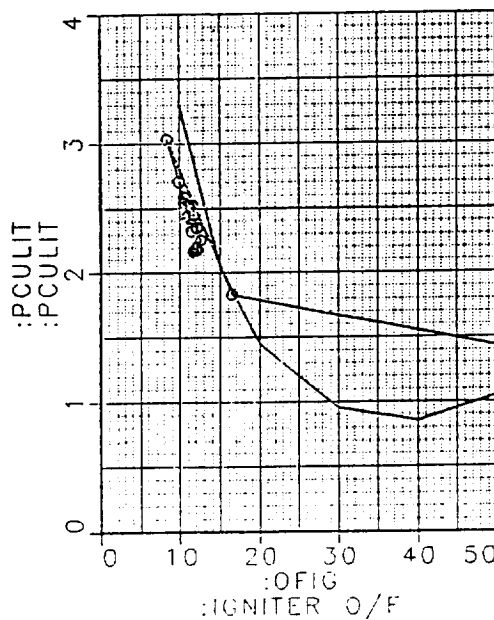
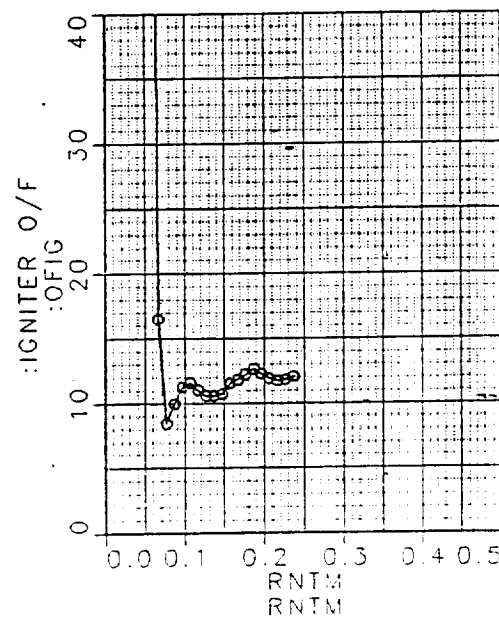
Figure-1 presents a typical run without evacuated fuel cooldown valves. Chamber conditions are shown to be well positioned within the predicted ignition range. Igniter conditions are shown to be near the oxidizer lean side of the ignition range. A calculated chamber pressure is used because of the slow response of the measured chamber pressure.

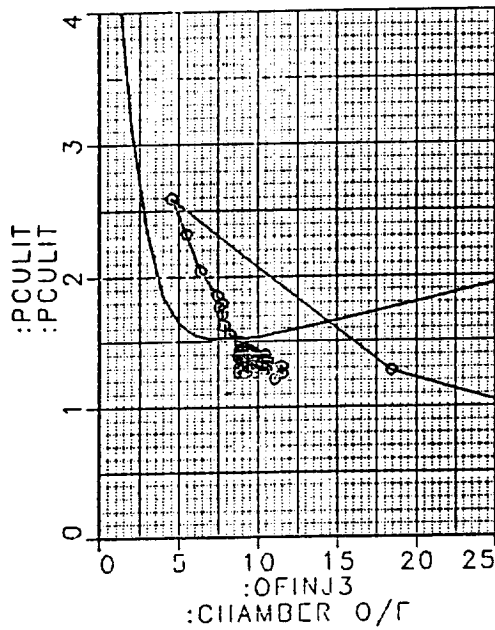
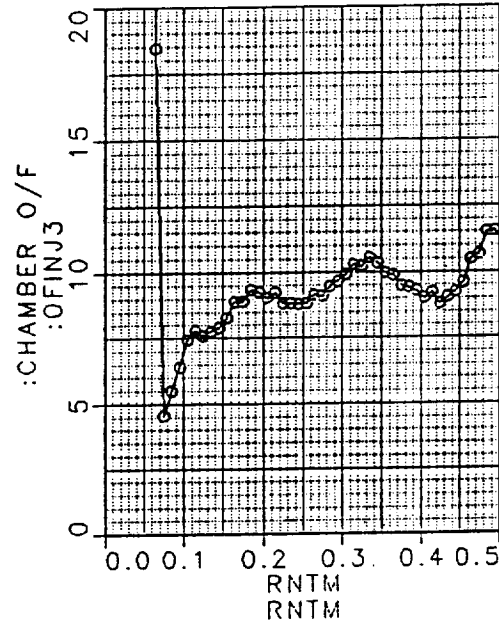
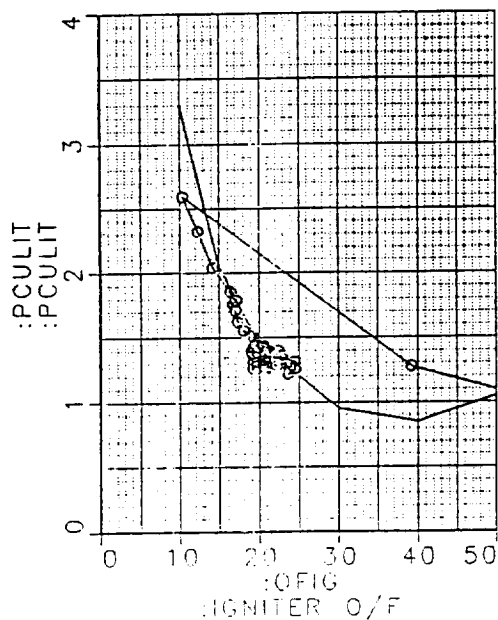
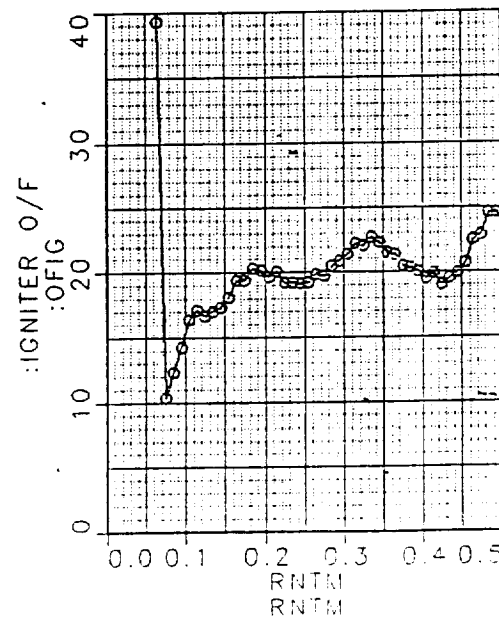
## FIGURE - 2

Figure-2 presents a typical run with evacuated fuel cooldown valves. Chamber mixture ratio is shown to be well positioned, but chamber pressure is below the predicted ignition range. Igniter conditions are shown to be near the oxidizer lean side of the ignition range. A calculated chamber pressure is used because of the slow response of the measured chamber pressure.

RESULTS --- ON LIGHT
